# **Effects of Stream Crossing Upgrading on Channel Erosion**

September 7, 2005

Richard Harris, Jared Gerstein and Pete Cafferata

University of California, Berkeley

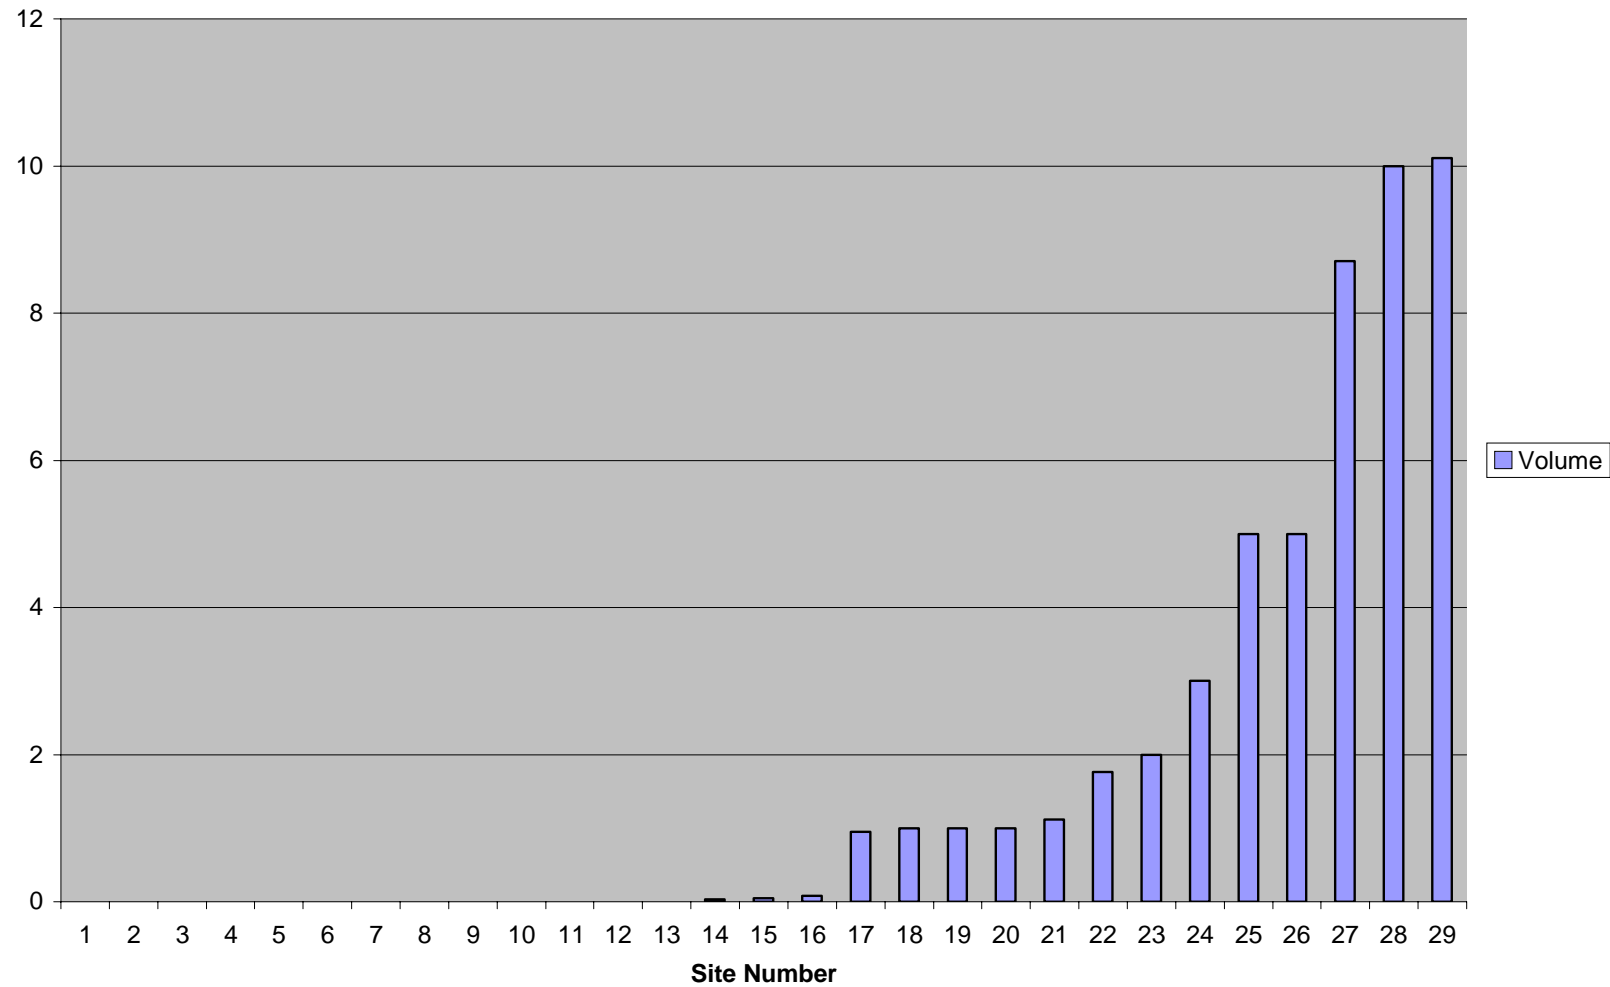
Adjustment Volume Due to Upgrade

- Thirteen of 29 sites showed no discernible erosion or sediment delivery.
- Only five sites produced more than five cubic yards of sediment.
- Maximum sediment production was about 10 cubic yards (at two sites).

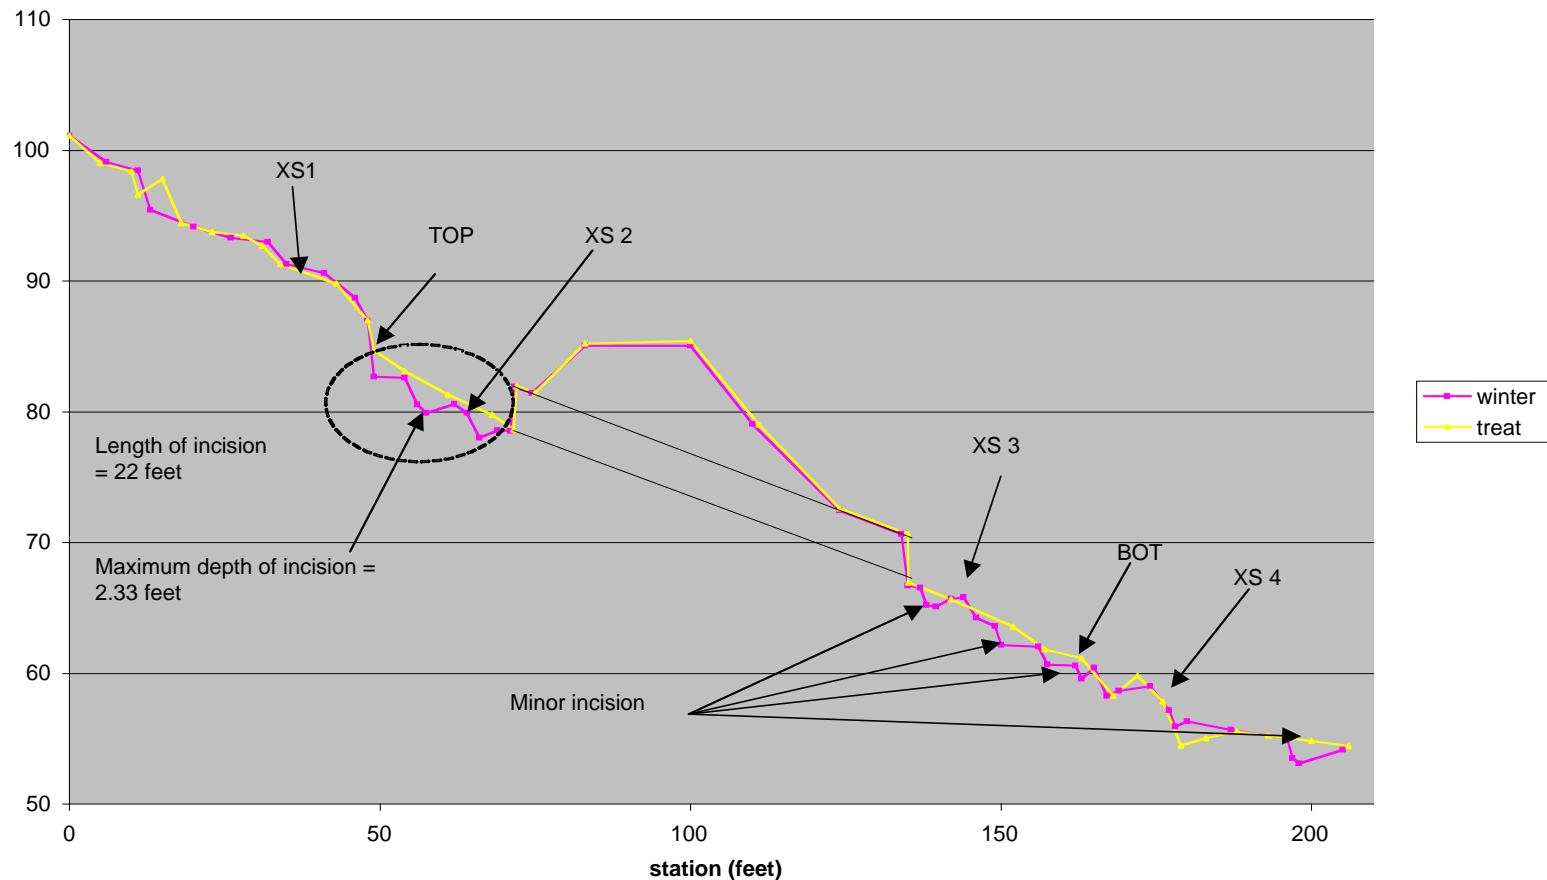
Turkeyback 660

- Analysis of profiles indicated instances of channel incision ("TOP and BOT" indicate limits of excavation). Maximum depth of incision was about four feet. Maximum length of incision was about 40 feet.

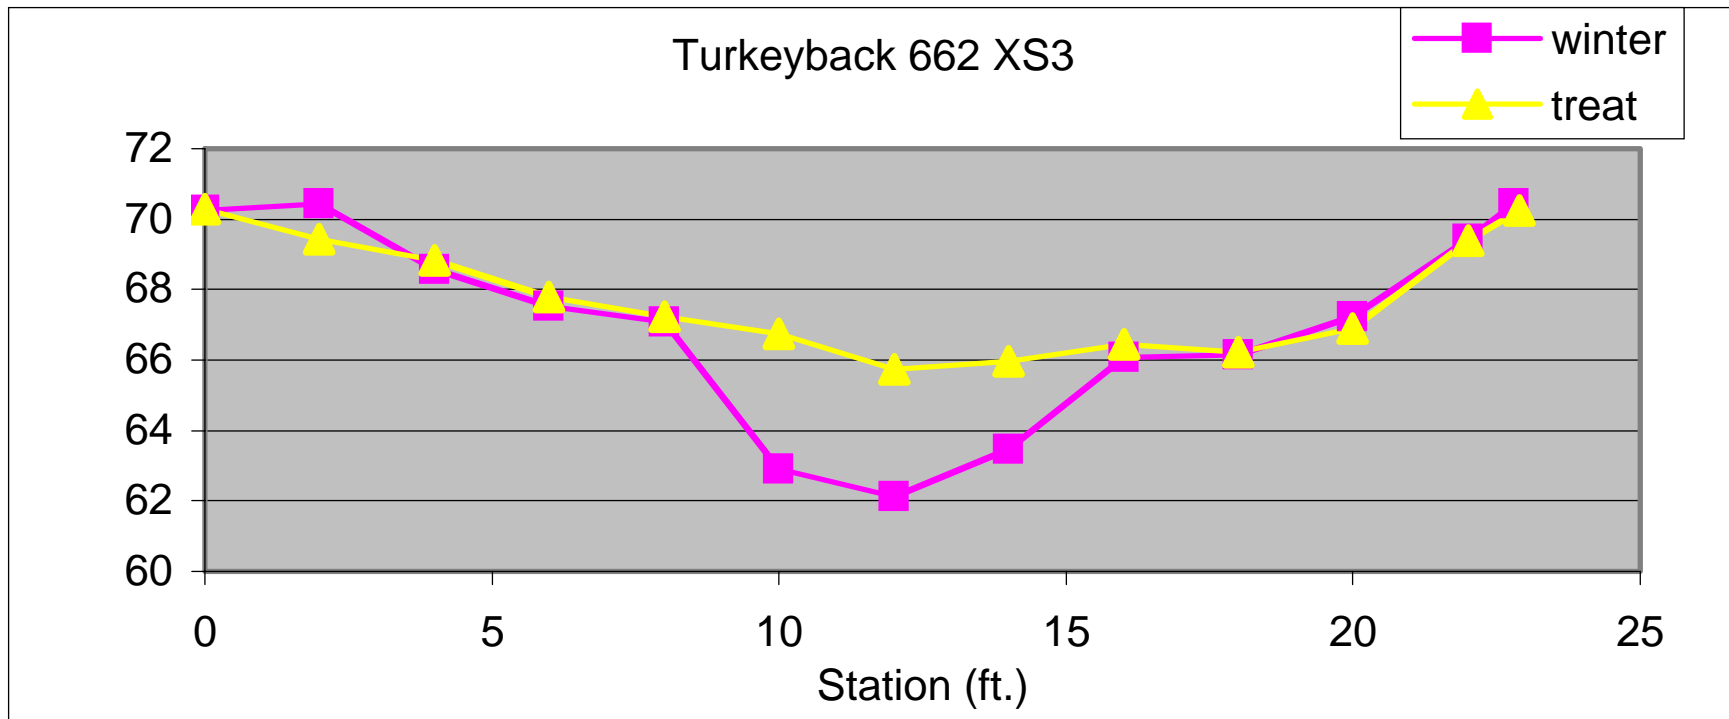
- Few cross sections displayed significant changes. Cross sections were not sufficiently close enough to capture all channel changes. Void measurements were more useful.

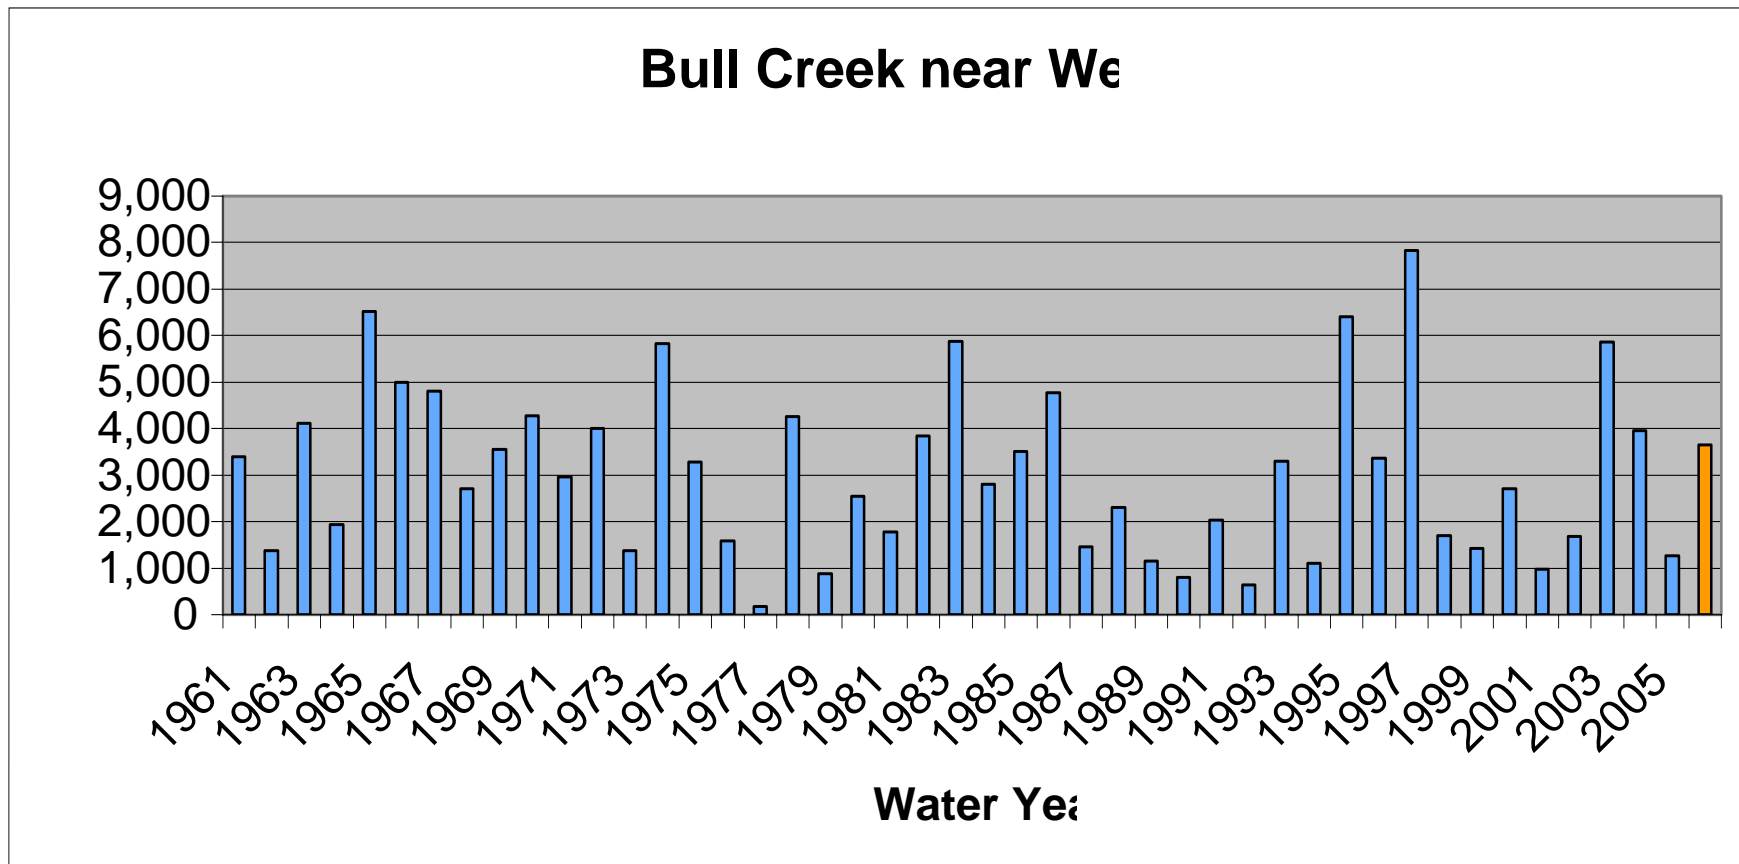
- Available data indicates that the winter of 2005-06 was of moderate severity in most places. Precipitation events never exceeded a two-year recurrence interval storm as recorded at Humboldt County stations.
- Streamflow: Bull Creek experienced a 3.5 year recurrence interval peak flow (nearest station to Palco).

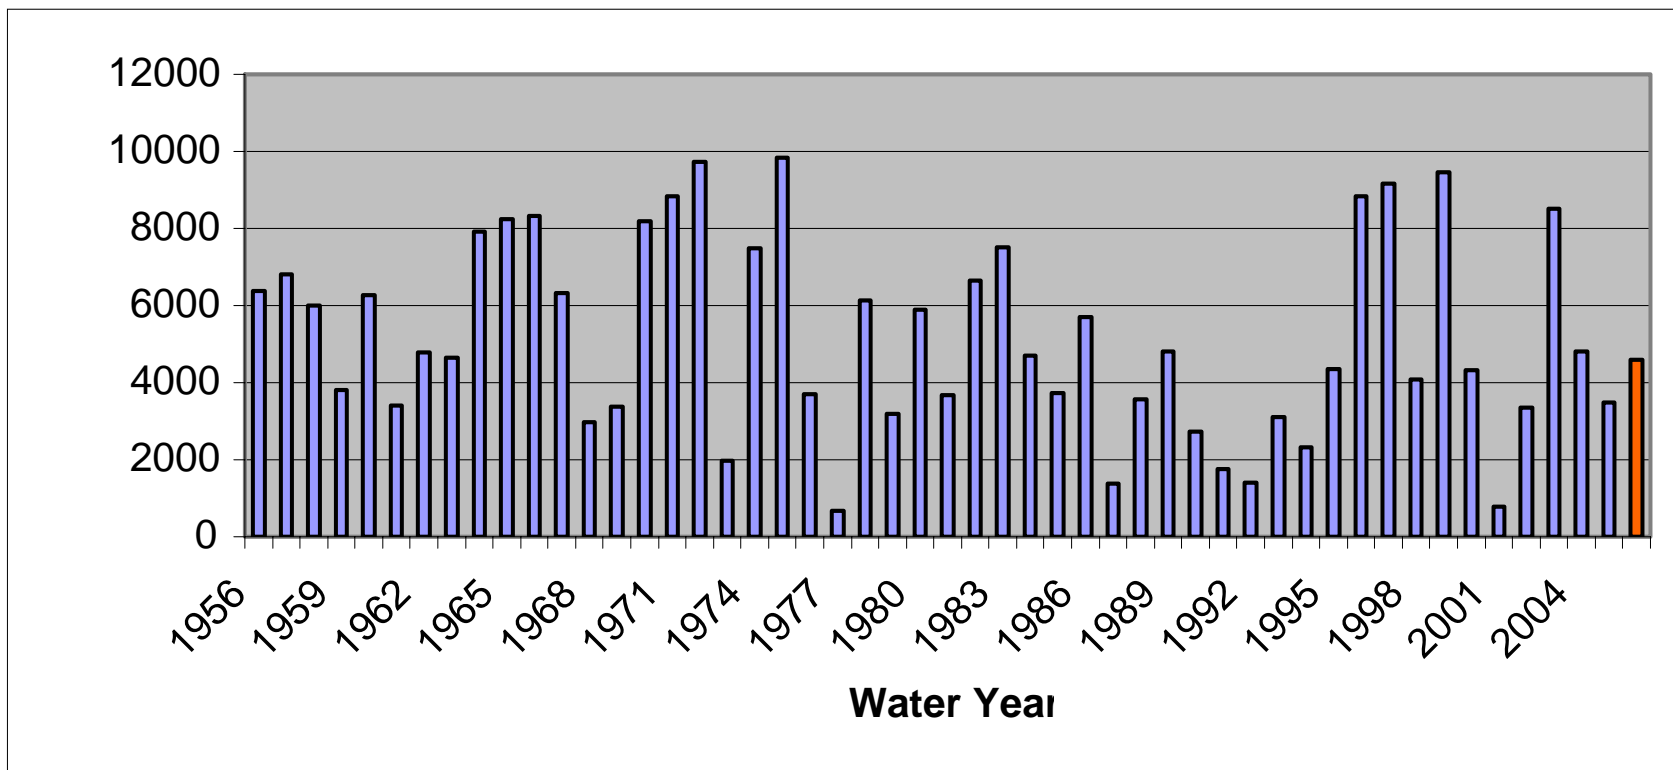
- The Little River experienced a two-year recurrence interval peak flow (nearest station to Green Diamond).

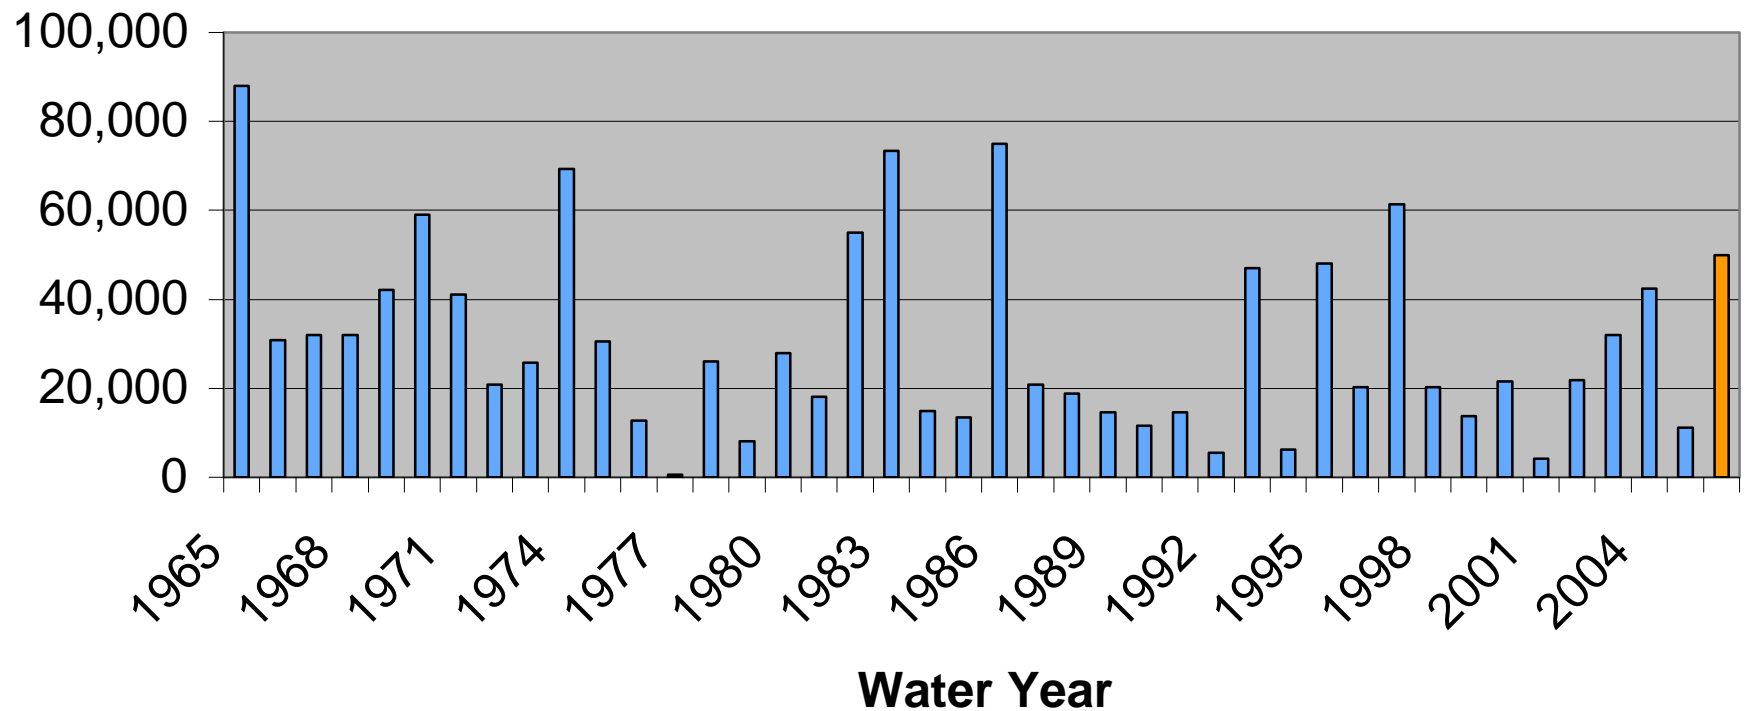
**South Fork Trinity River near Hyampom**

- Unregulated South Fork Trinity experienced a 7.5 year recurrence interval discharge (nearest to Hoopa).
